*Mill Pond Bathymetric Survey
and Sediment Sampling Study*

Durham,
New Hampshire

Durham Mill Pond Bathymetry and Sediment Sampling Study

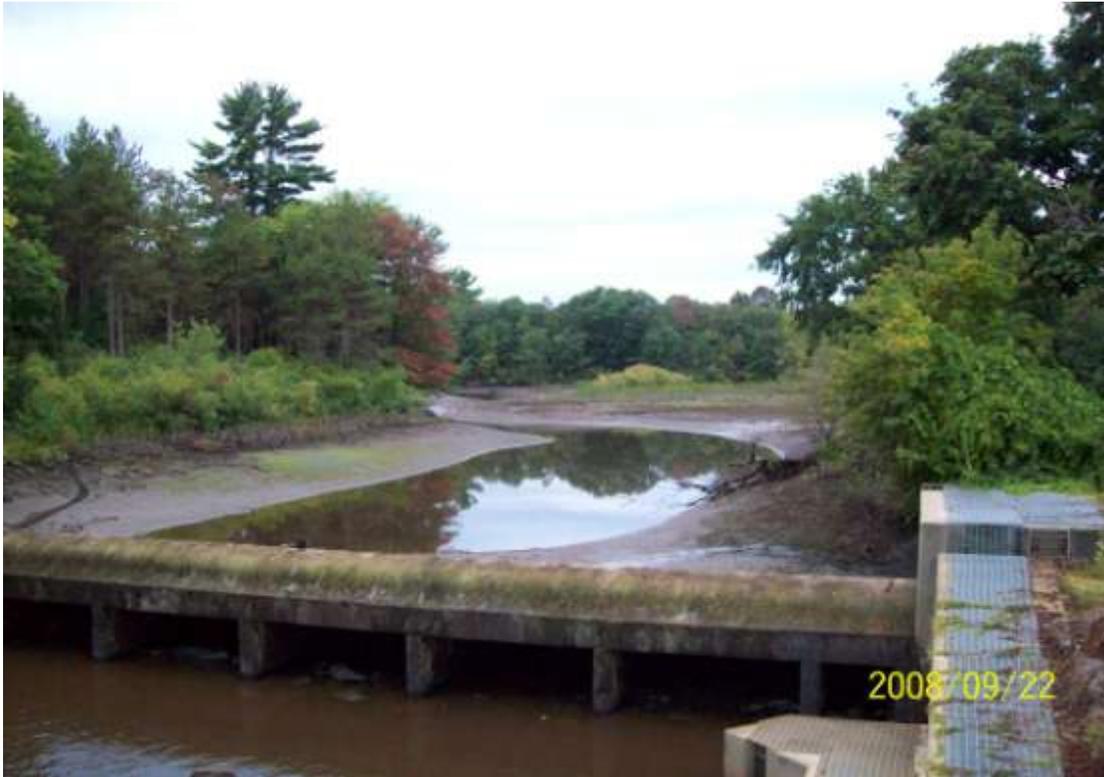
Photo 1 – View of river channel during September 2008 drawdown upstream of a dam.

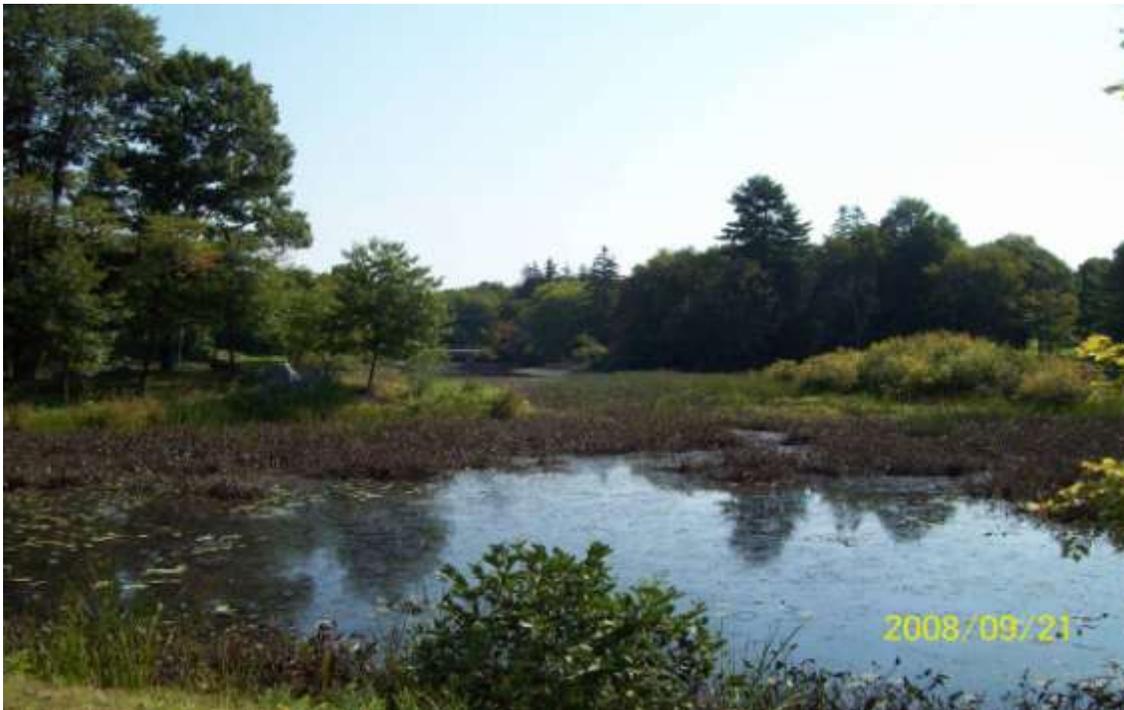
Photo 2 – View of Pond from Mill Pond Road showing a mix of vegetation and standing water.

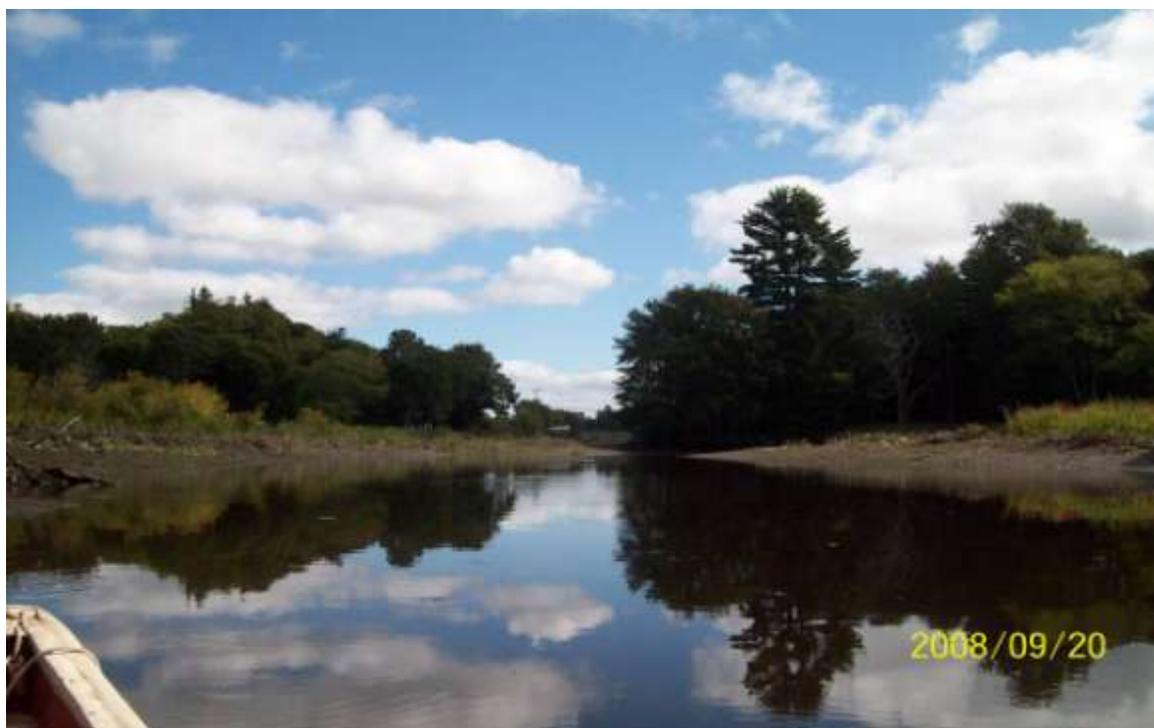
Photo 6 – View of river channel looking east towards dam showing exposed banks during the middle of drawdown period.

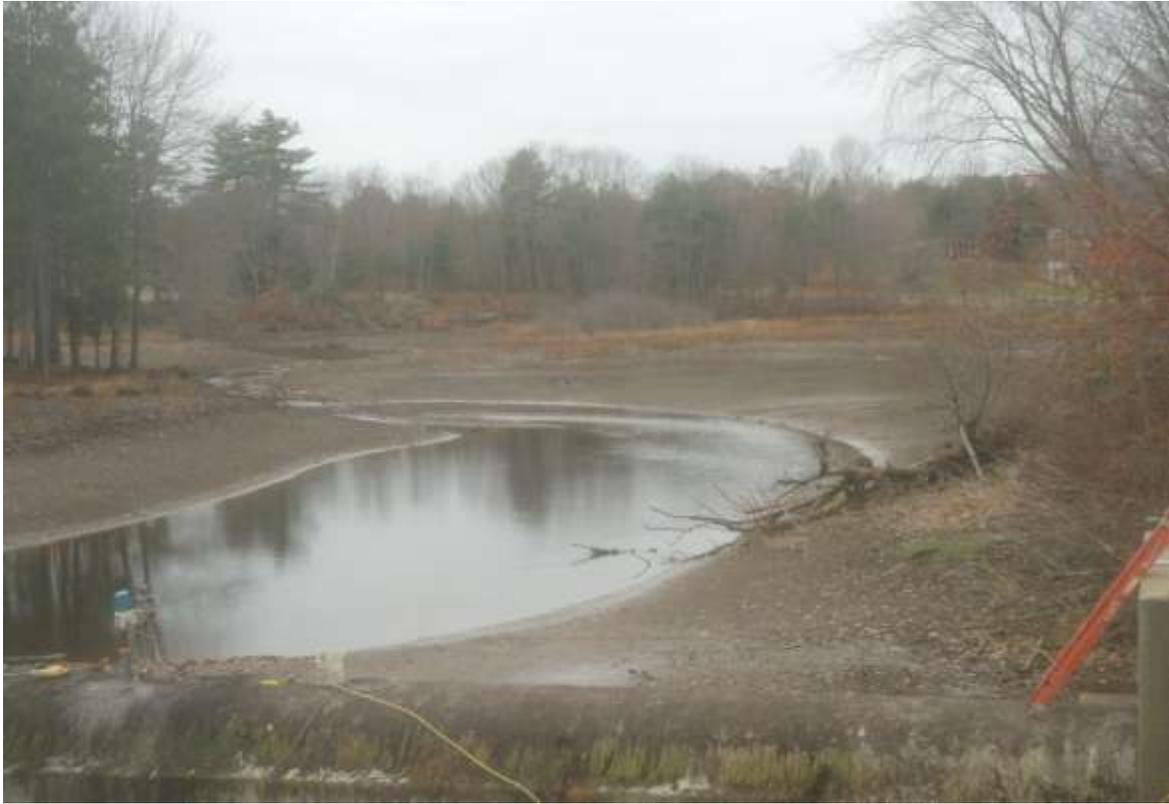
Photo 1 – View of channel just upstream of dam. Photo taken on 11/23/2009.

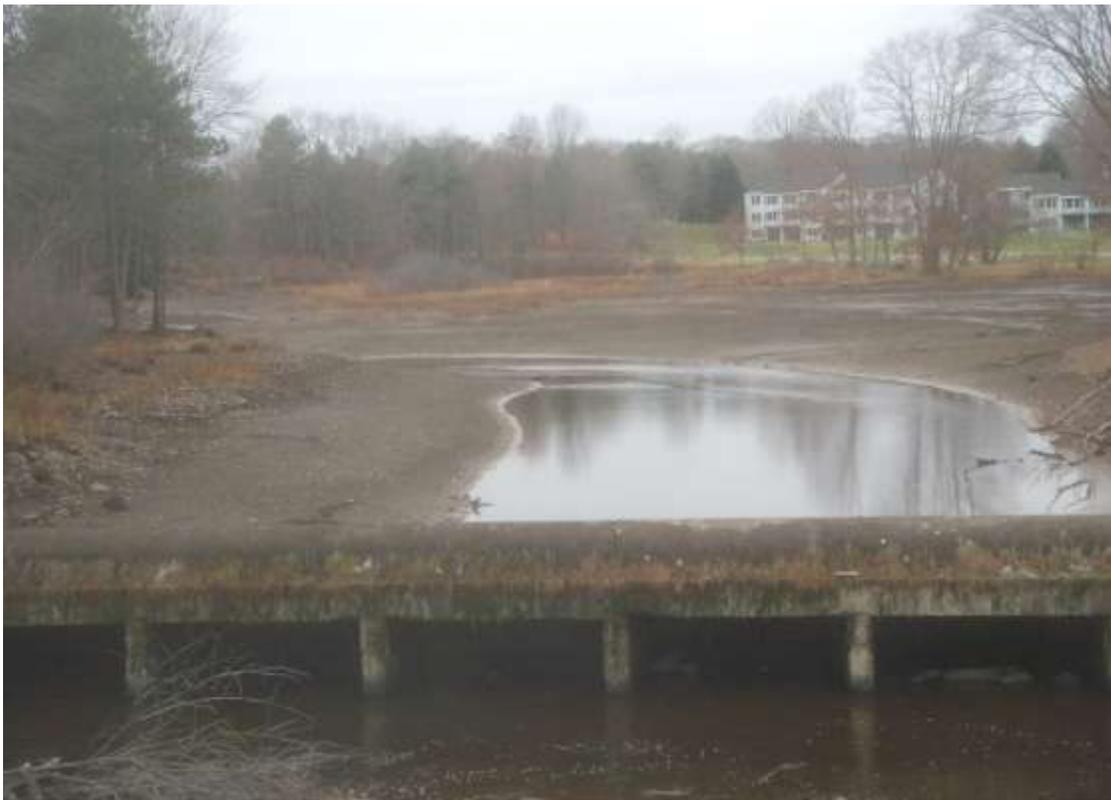
Photo 4 – View from Rte 108 Bridge looking towards Mill Pond Road and dewatered Pond. Photo taken on 11/23/09.

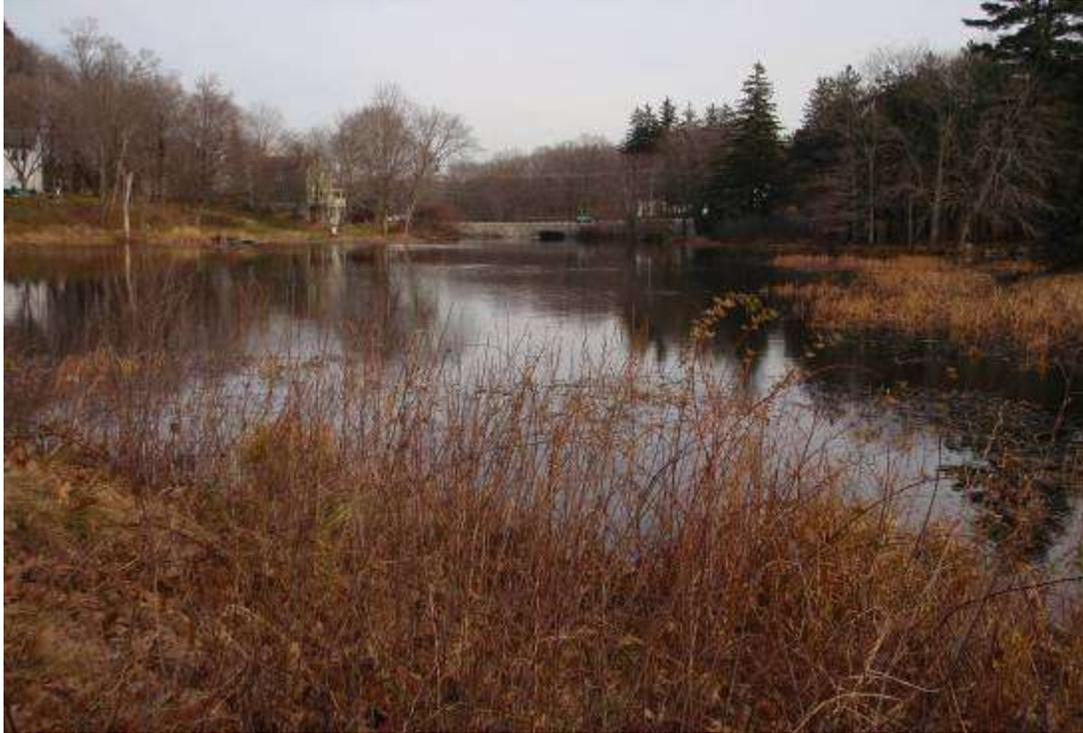
Photo 1: Multiflora rose and other invasives on bank of small plateau reaching out towards the center of Pond from the western side. Oyster River Dam in the background (to the northeast).

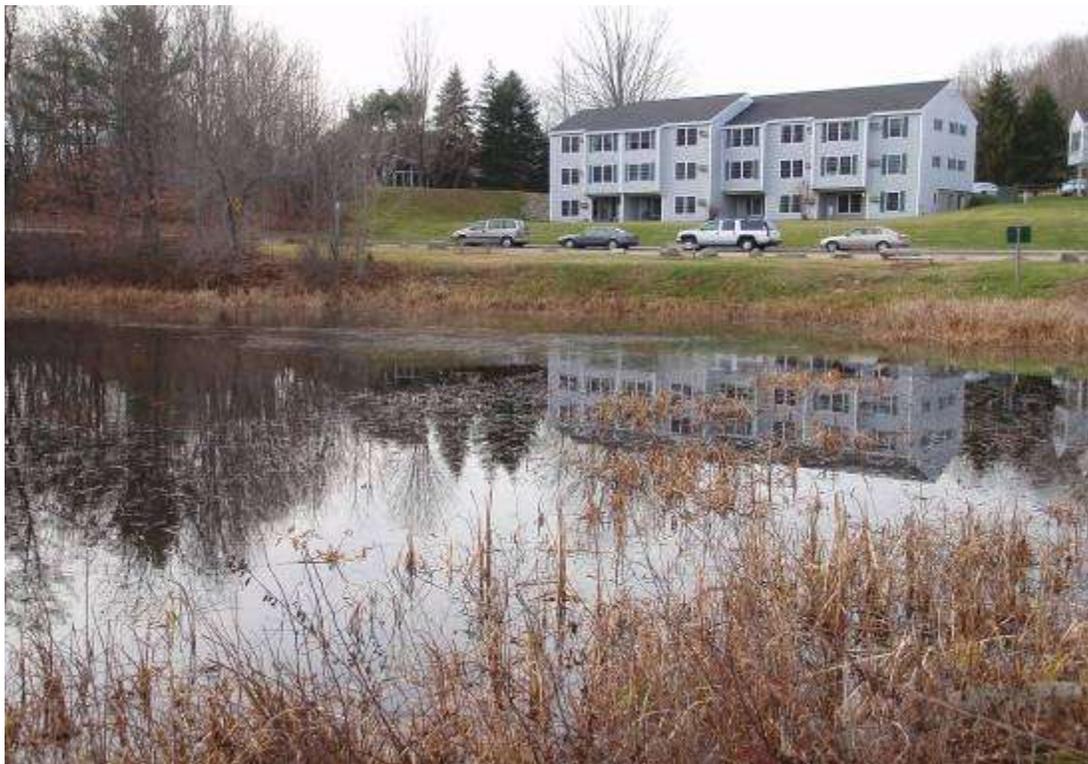
Photo 2: View southwest from small plateau to the western banks of Mill Pond. Woolgrass, broad-leaf cattail, and purple loosestrife are dominant throughout this area.

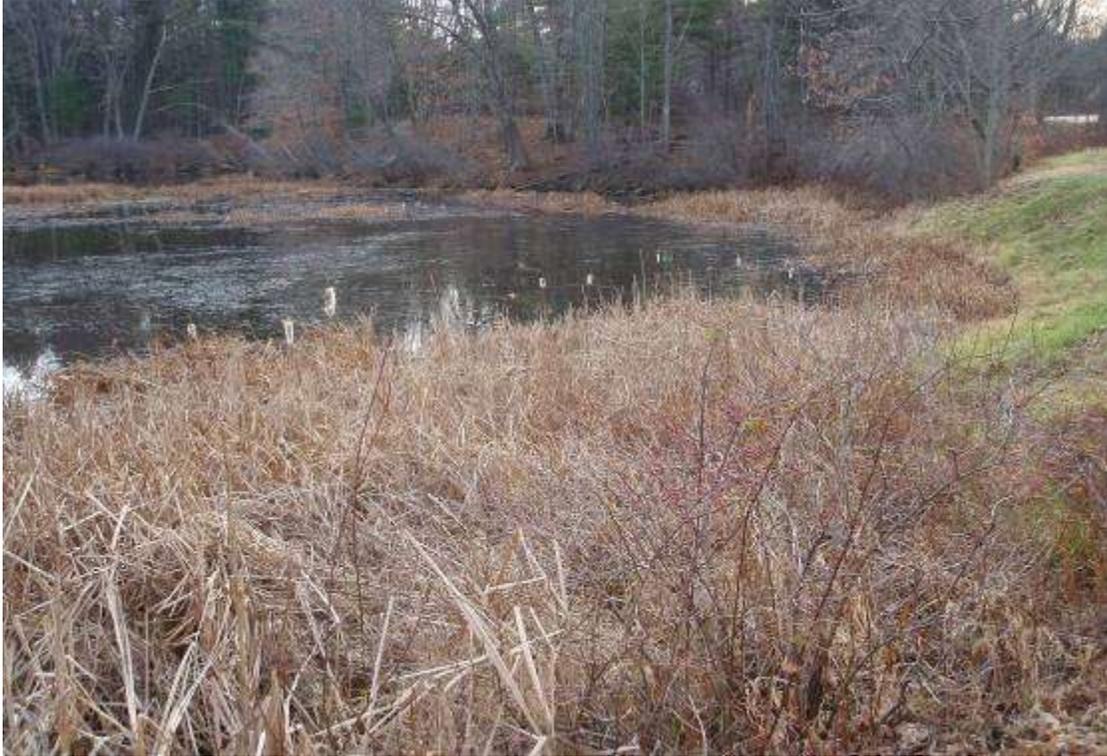
Photo 3: View south to a mixture of invasive and native emergent vegetation along the western banks of Mill Pond.

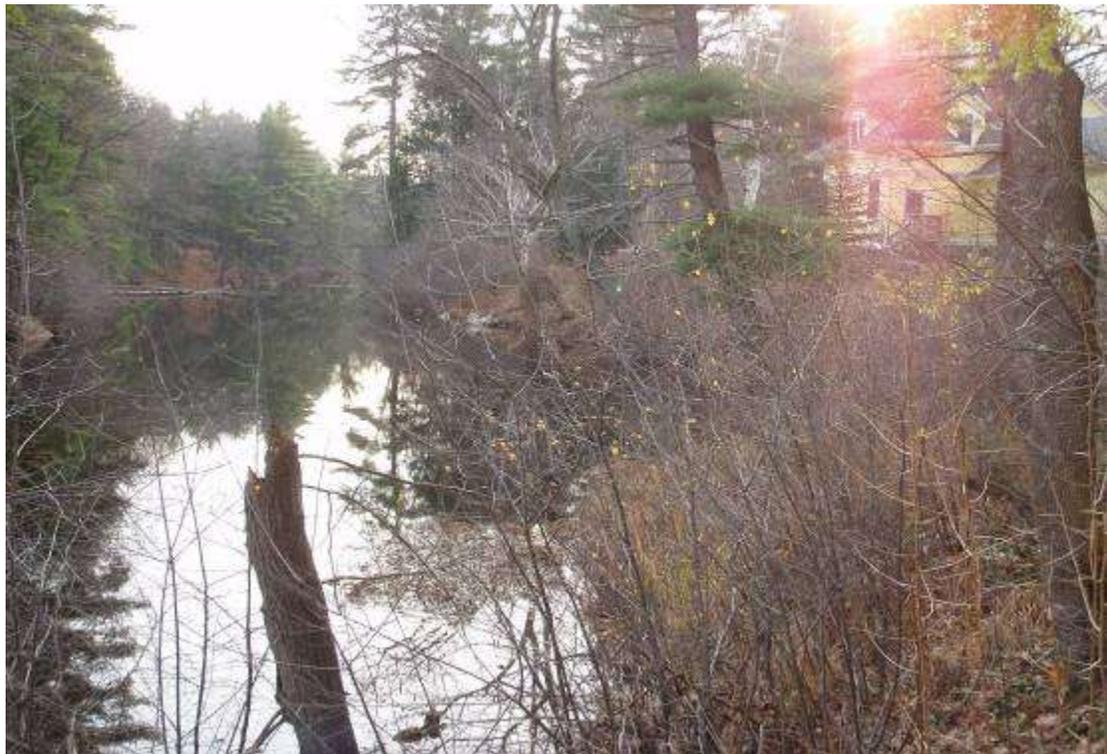
Photo 4: View south along the western banks of the Oyster River just before it flows into Mill Pond. Banks along this portion are steeply sloped with mainly eastern white pine and northern red oak.

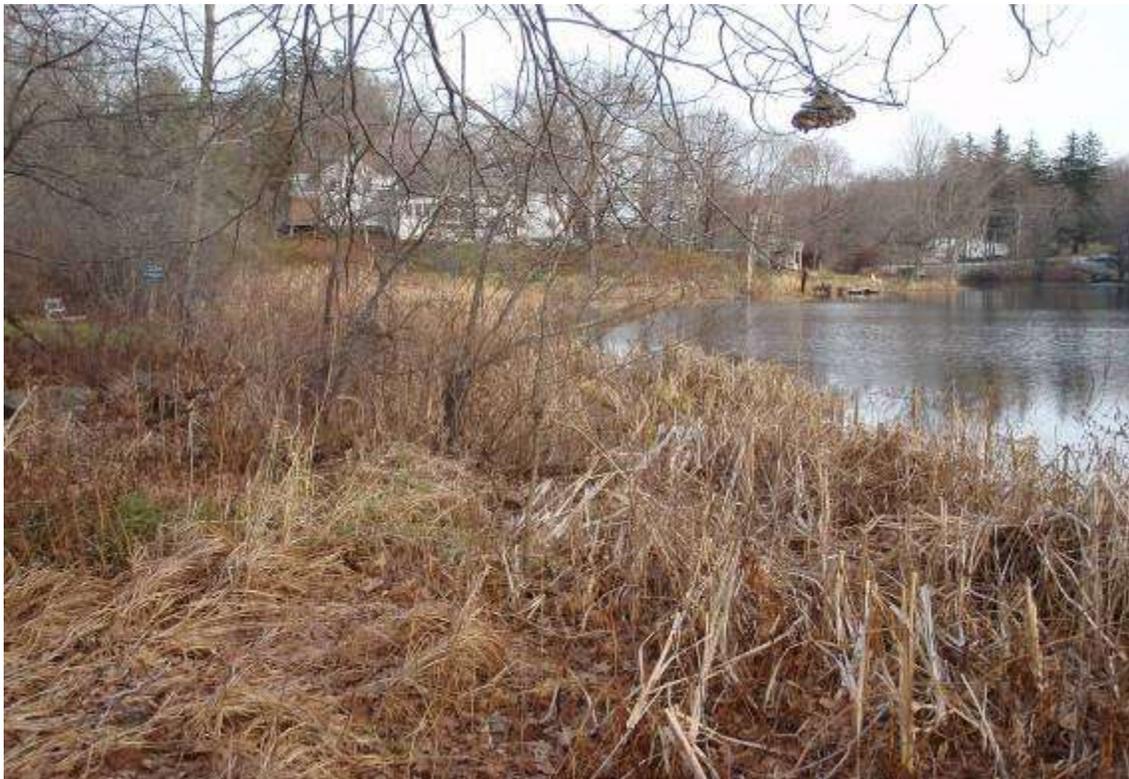
Photo 6: Emergent marsh areas along the northern portions of Mill Pond's western banks.

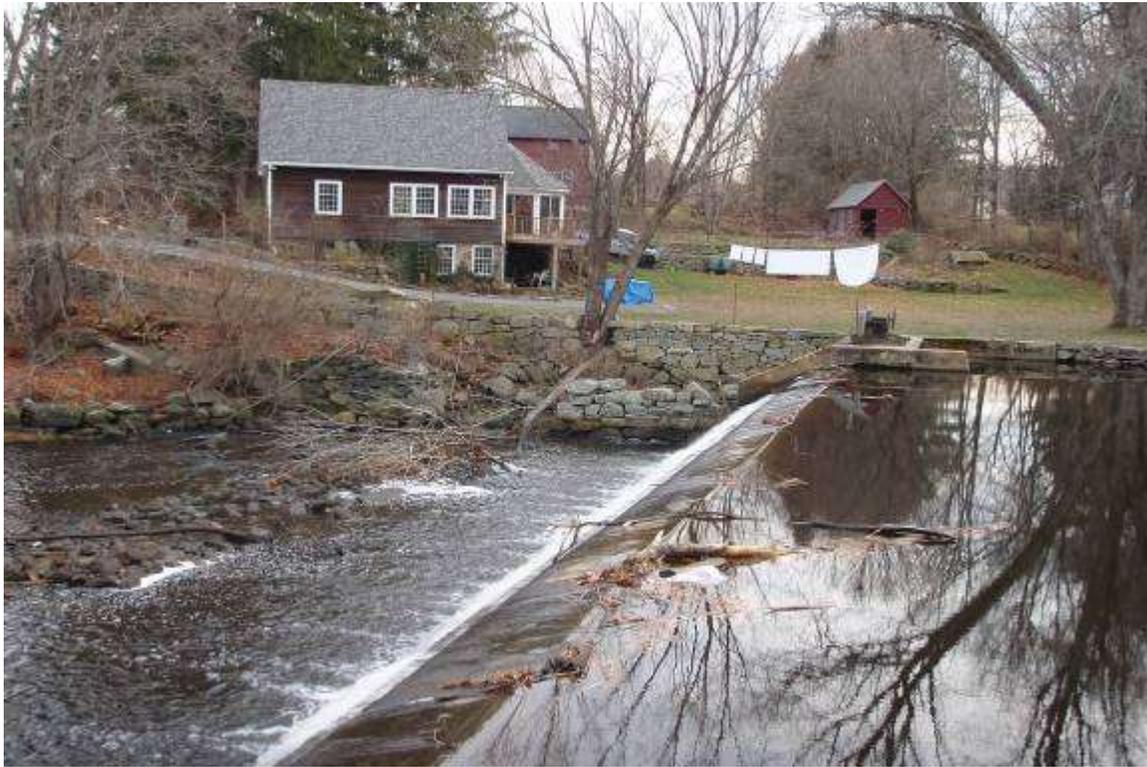
Photo 8: View south towards the existing Oyster River Dam. Stone rip-rap lines the banks surrounding the dam.

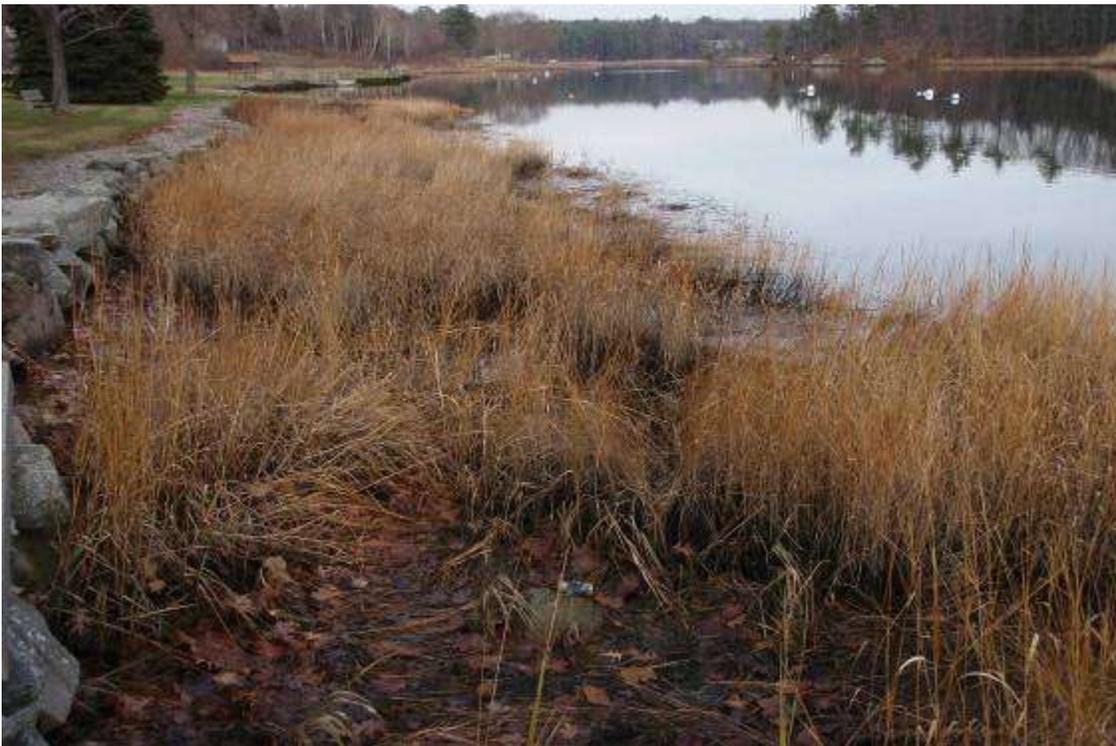
Photo 10: View east at native plant species including saltmeadow cordgrass, prairie cordgrass, blackgrass, and saltmarsh bulrush.

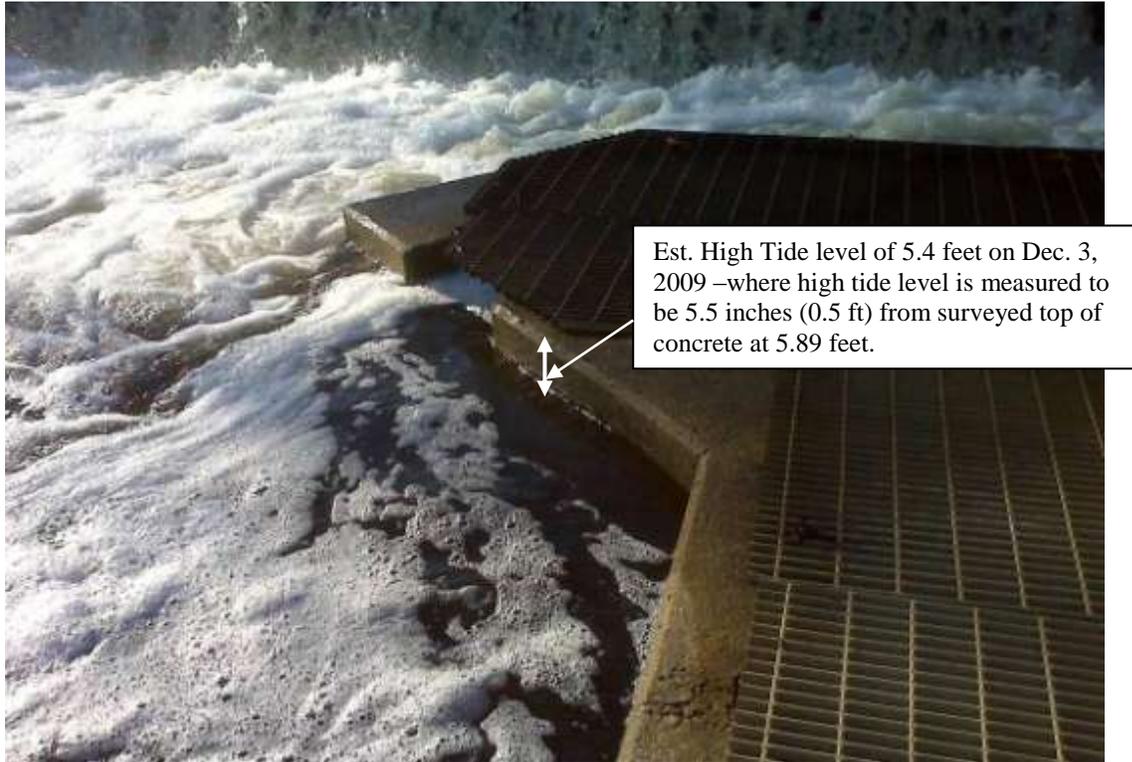
Oyster River Dam Fish Ladder Hydraulic Outlet, Durham, NH – 1:10 PM December 3, 2009

Est. High Tide level of 5.4 feet on Dec. 3, 2009 –where high tide level is measured to be 5.5 inches (0.5 ft) from surveyed top of concrete at 5.89 feet.

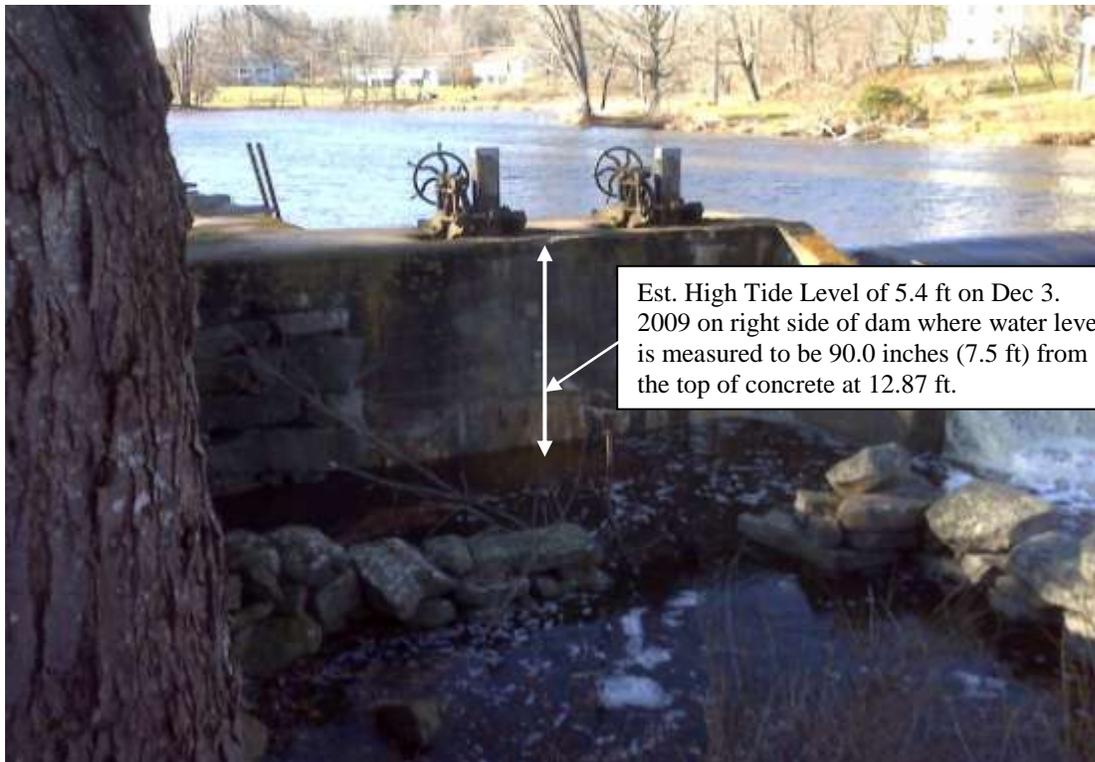
Oyster River Dam Left Abutment, Durham, NH – 1:14 PM December 3, 2009

Est. High Tide Level of 5.4 ft on Dec 3, 2009 on right side of dam where water level is measured to be 90.0 inches (7.5 ft) from the top of concrete at 12.87 ft.

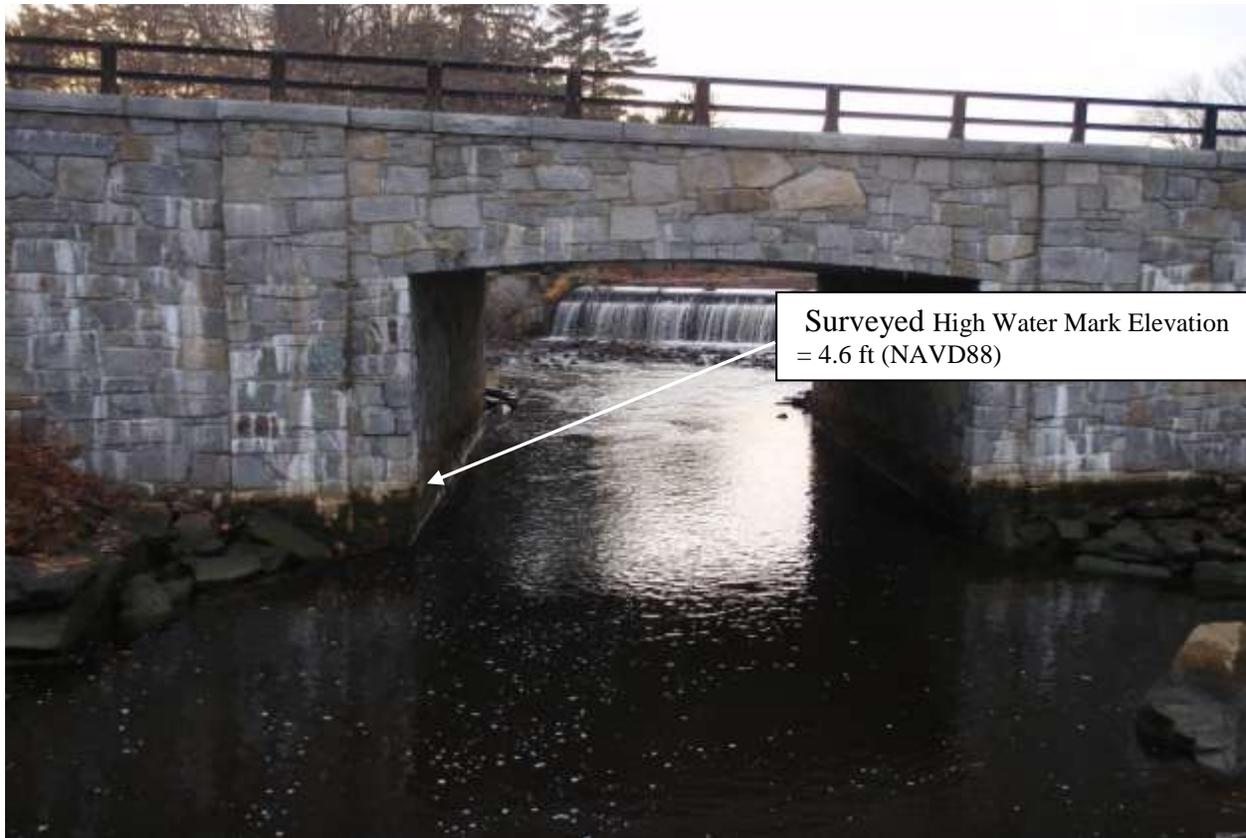
Appendix C – Photo of Potential MHHW Elevation Based on Survey of the High Water Mark on Stone Bridge Culvert
